# **EXHIBIT 3**

## **(Part 2 of 2)**

*M.Delvin & Associates, Inc. Project No. 2009.01  
Diamante, Cabo San Lucas*

*Project Review and Site Visit Report  
November 2015*

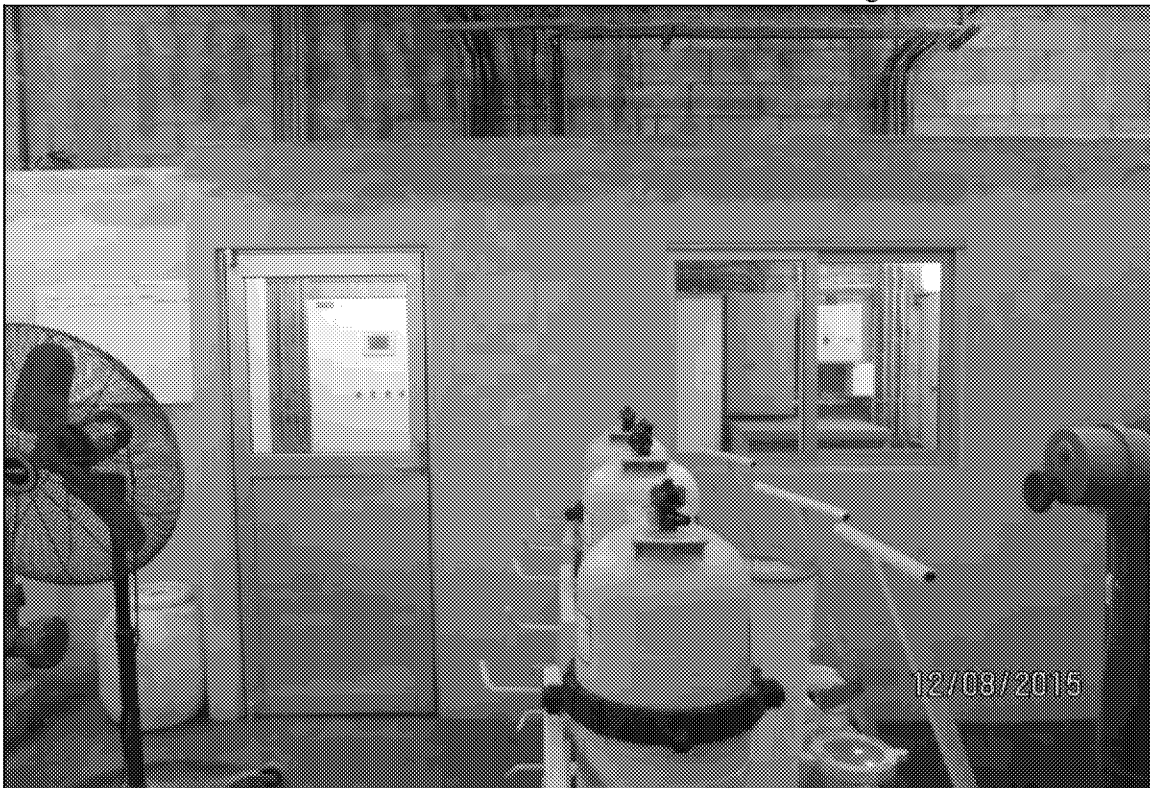
**Photograph 84:** Lagoon Pump and Filter Room: A new air-conditioned enclosure was constructed around the sensitive electronic equipment located within the pump room.

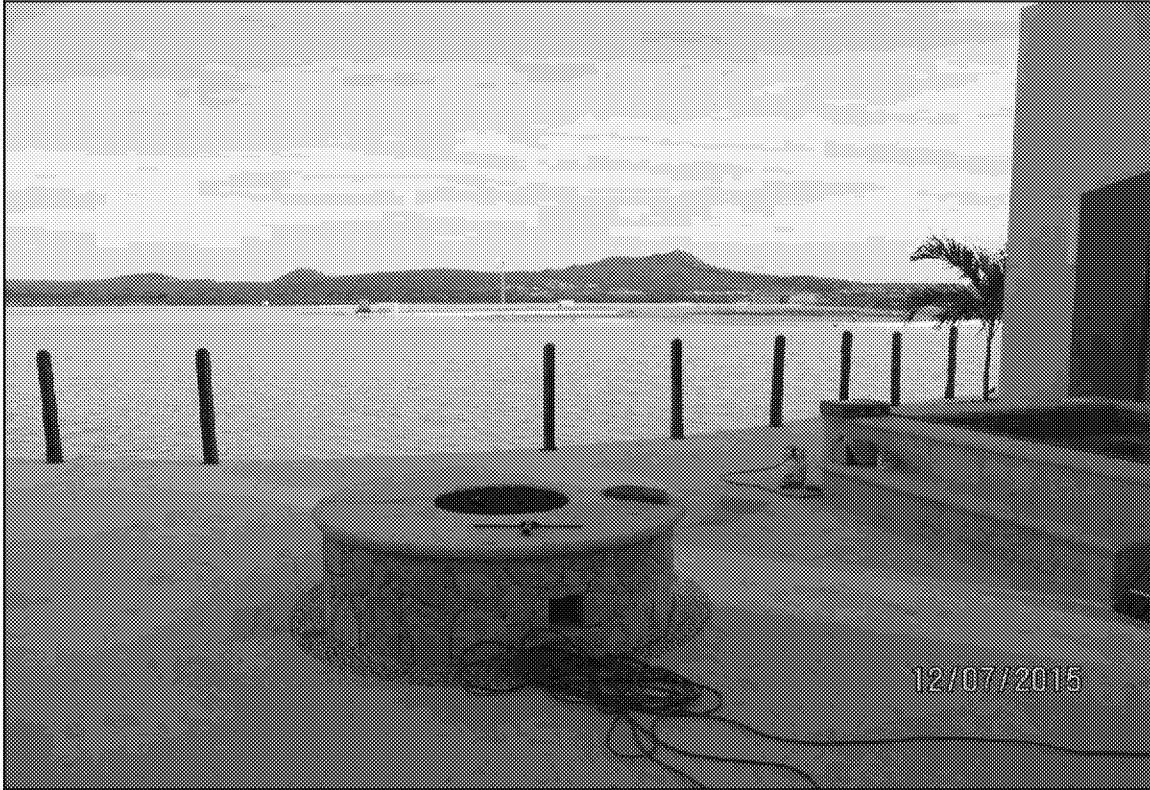
**Photograph 87:** Bungalow 7: The patio and finishes are complete but the dock has not been placed.

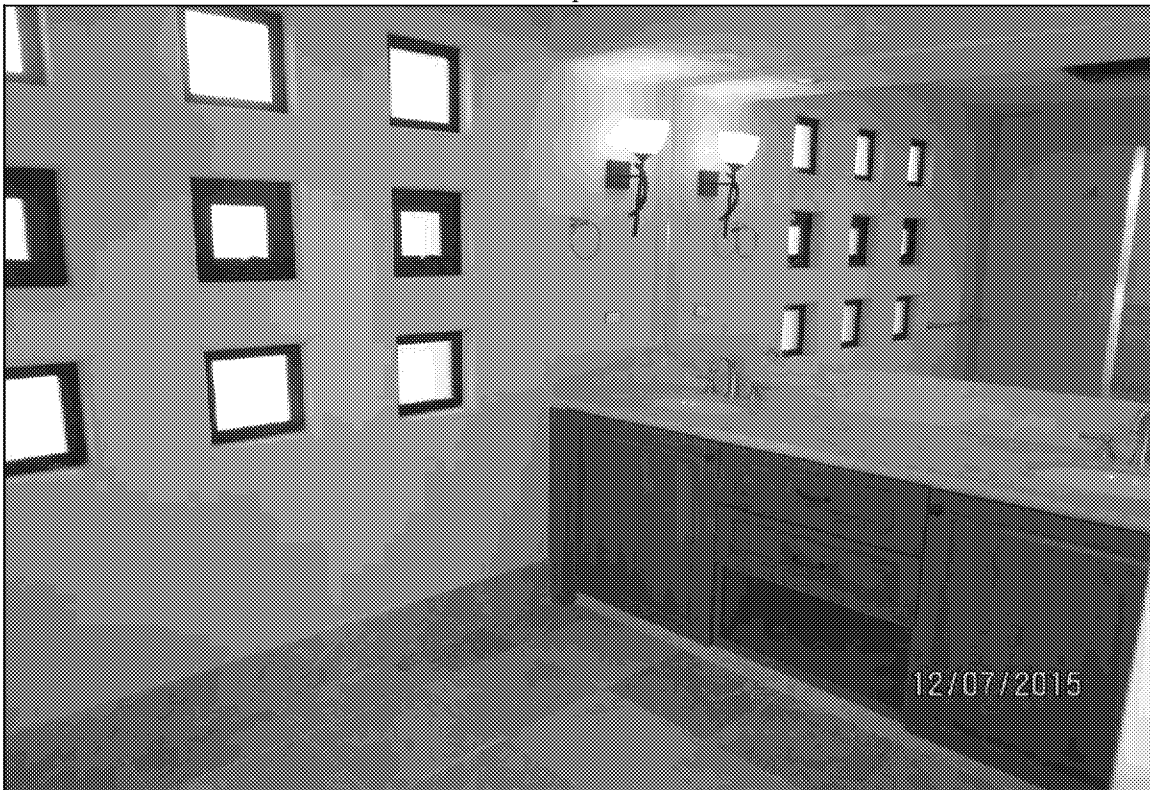
**Photograph 88:** Bungalow 7: All bathroom vanities, countertops, sinks and fixtures are complete.

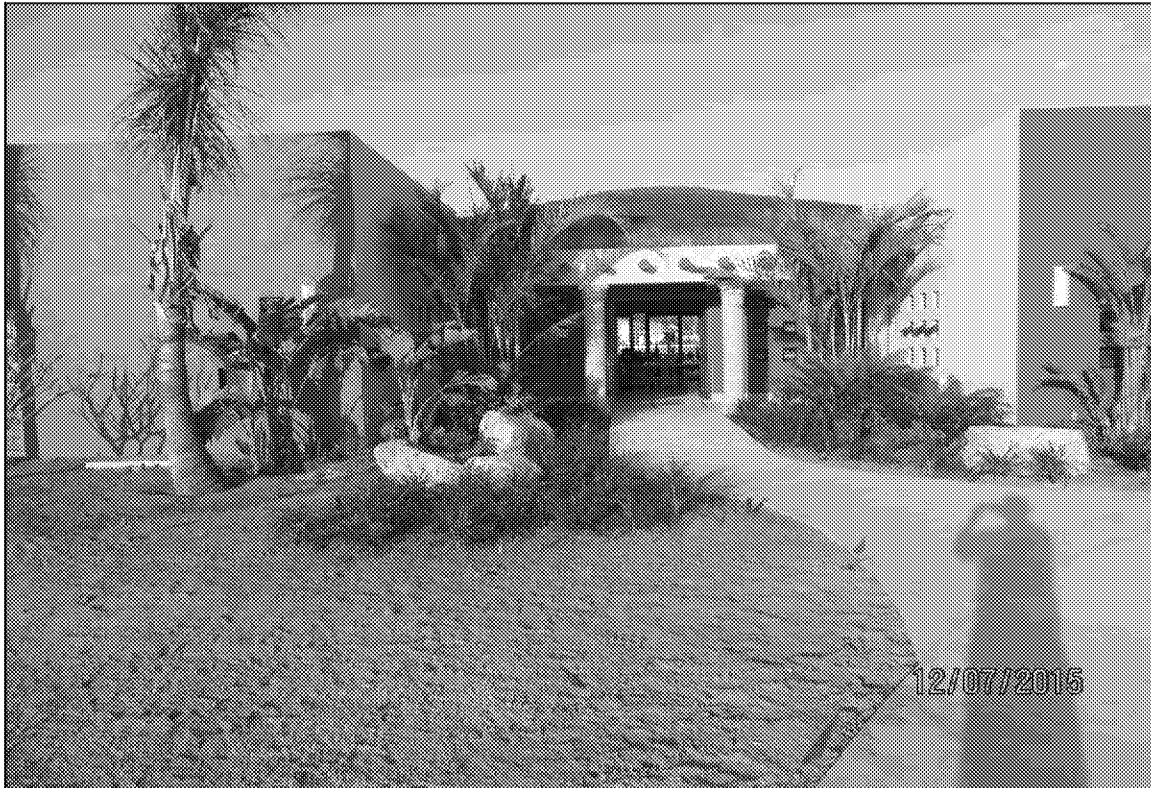
**Photograph 89:** Bungalow 8: The concrete walkway and cart path and landscaping is complete. The building exterior finishes are complete.

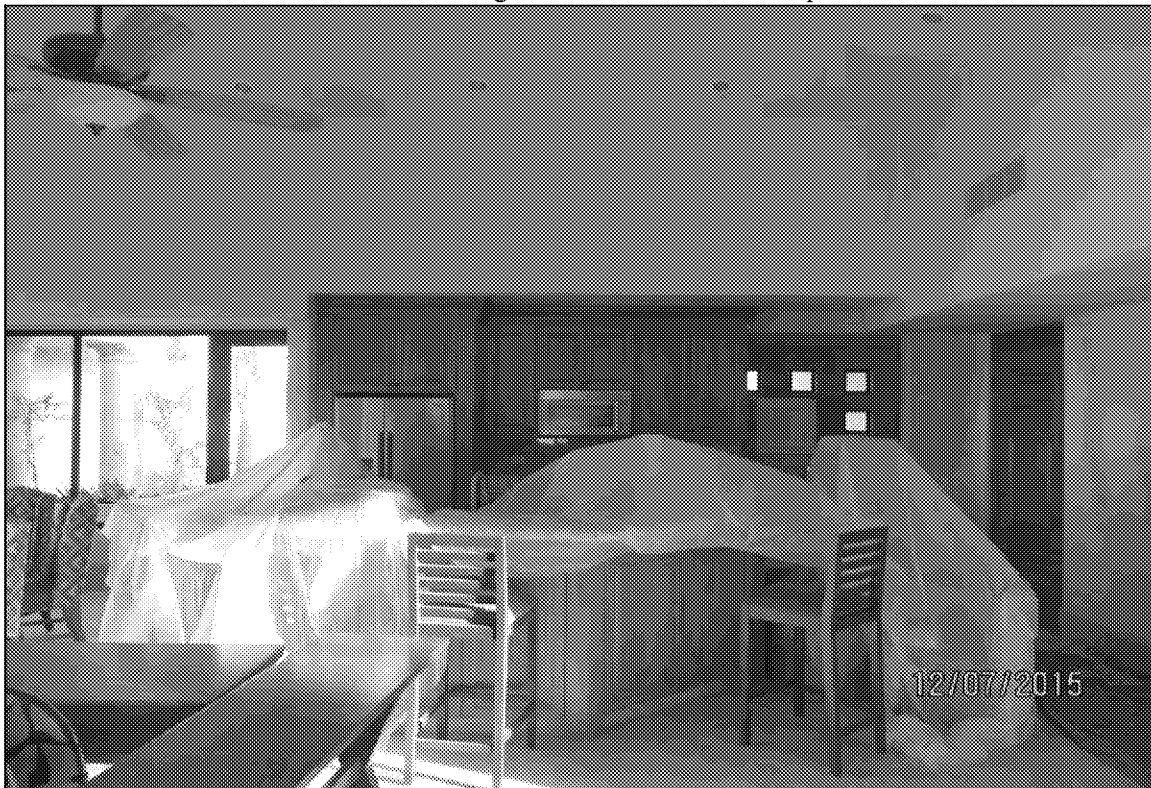
**Photograph 90:** Bungalow 8: Furniture has been delivered and is covered to allow punch-list work to be completed.

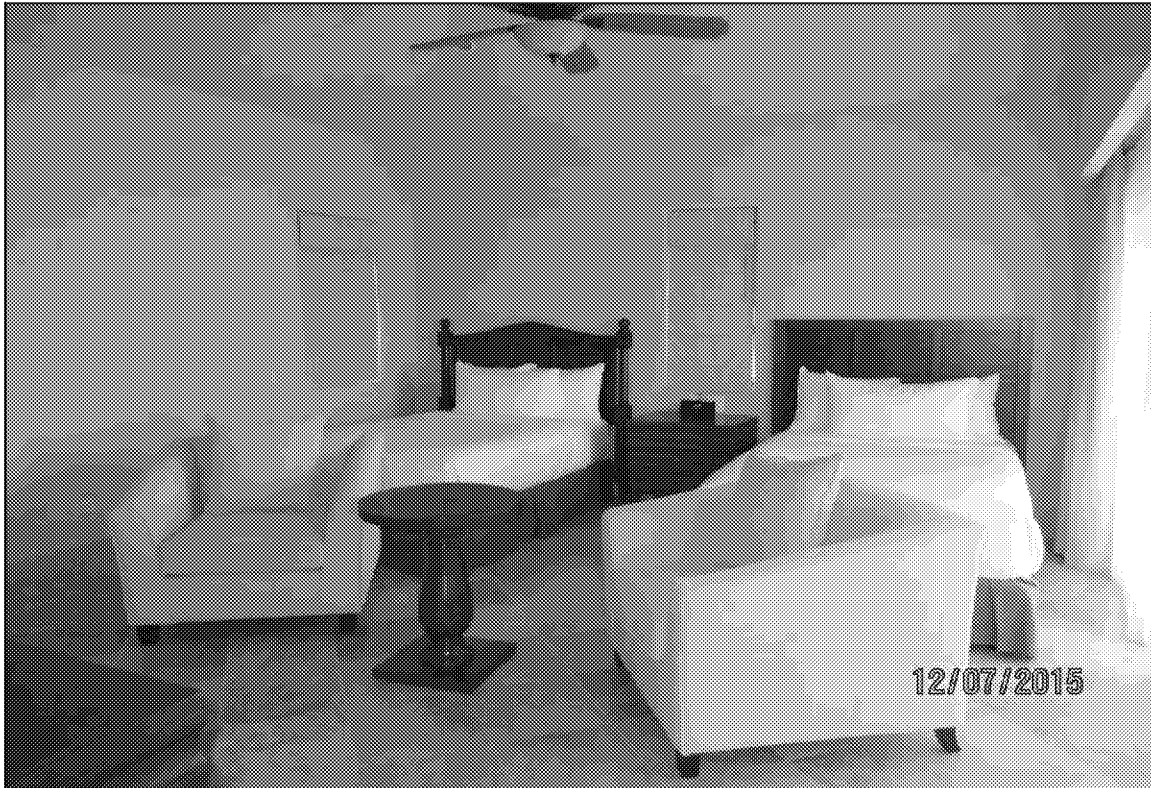
**Photograph 91:** Bungalow 8: Furniture such as this shown for the bedrooms is in place and the unit is generally ready to be occupied.

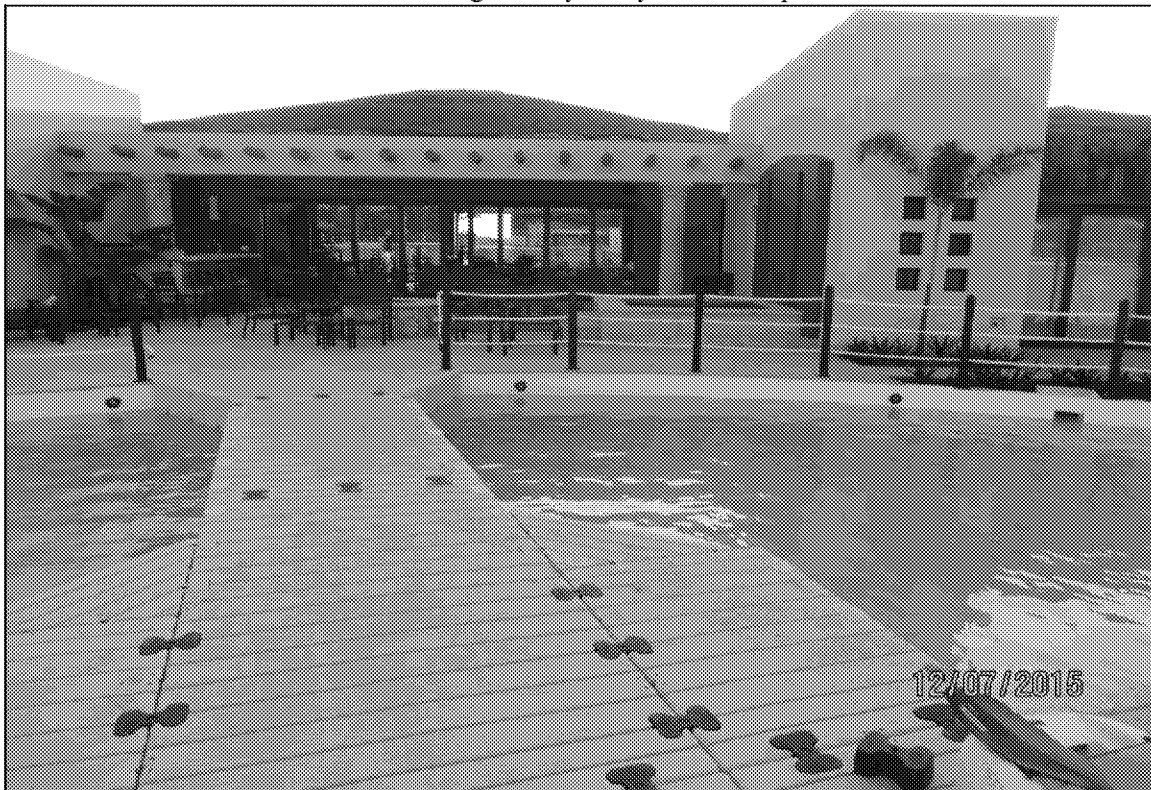
**Photograph 92:** Bungalow 8: The dock is in place and patio furniture is in place.

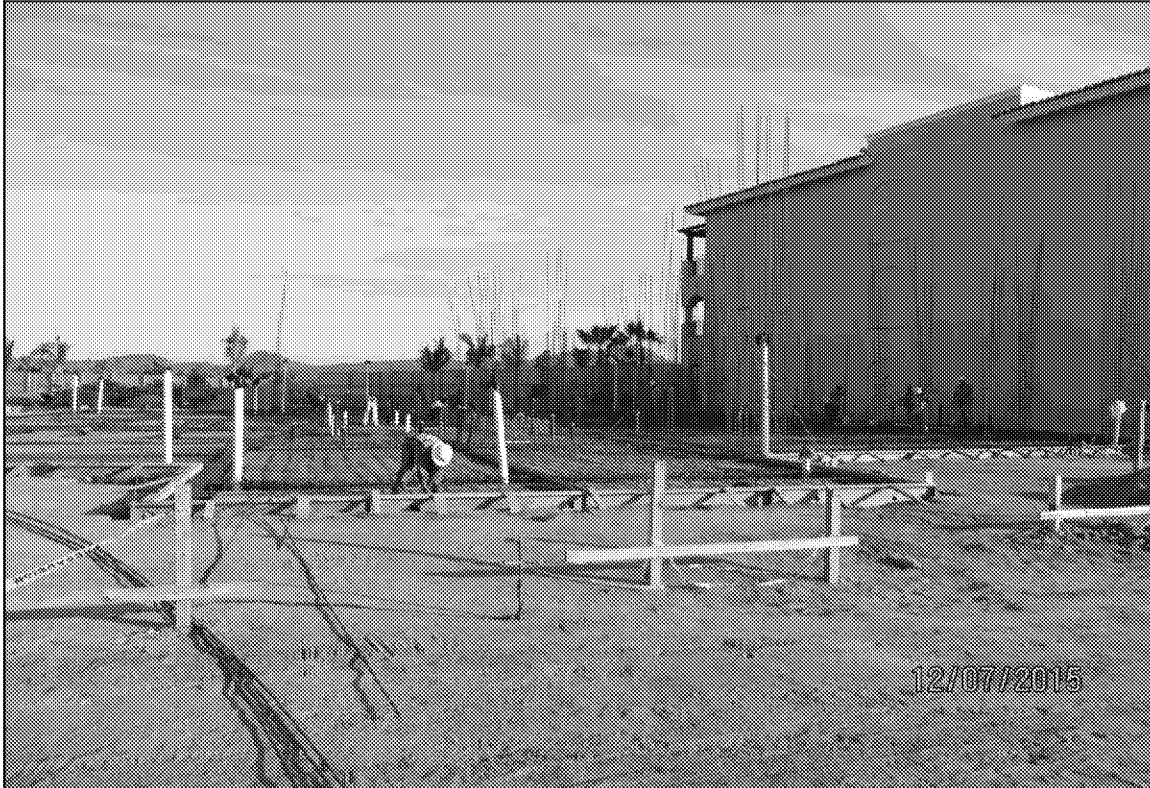
**Photograph 93:** Resort Low Rise Residential 1B: The excavation has been completed for 2/3 of the foundation and the foundation and slab are being prepared for casting.

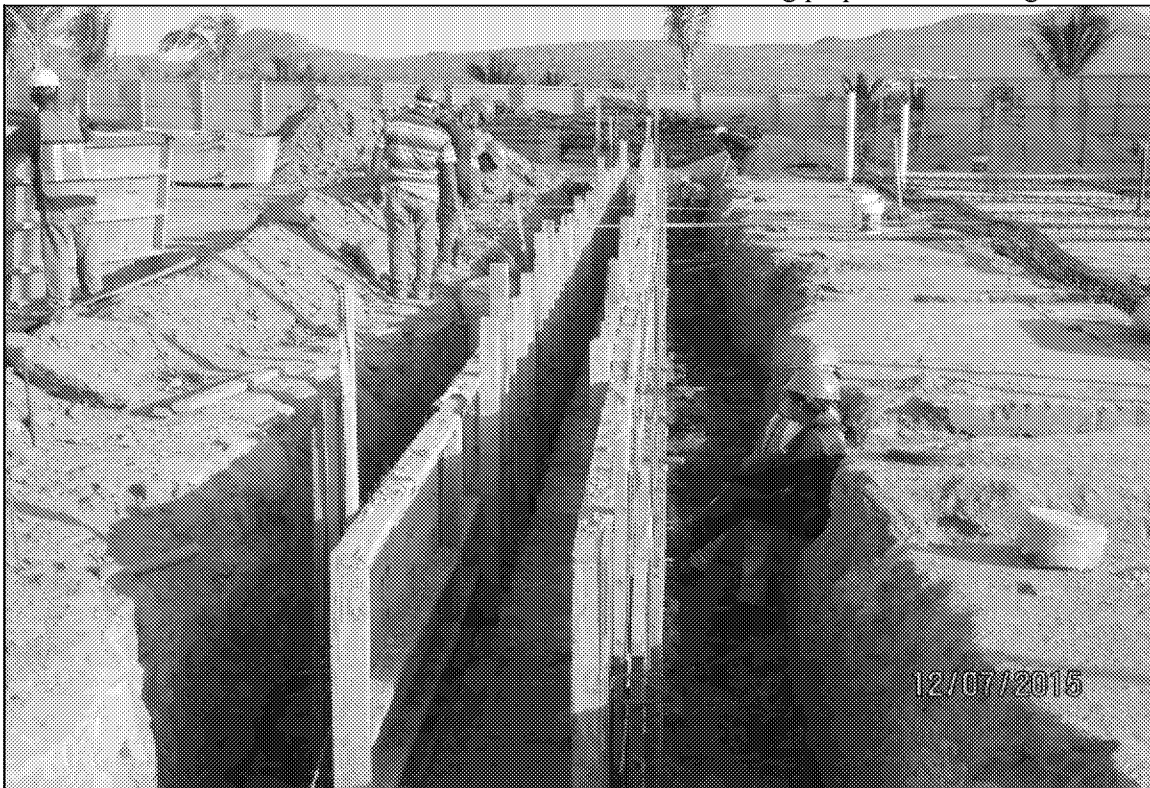
**Photograph 94:** Resort Low Rise 1B: Utility tunnels are constructed underground for access to underground utilities between units.

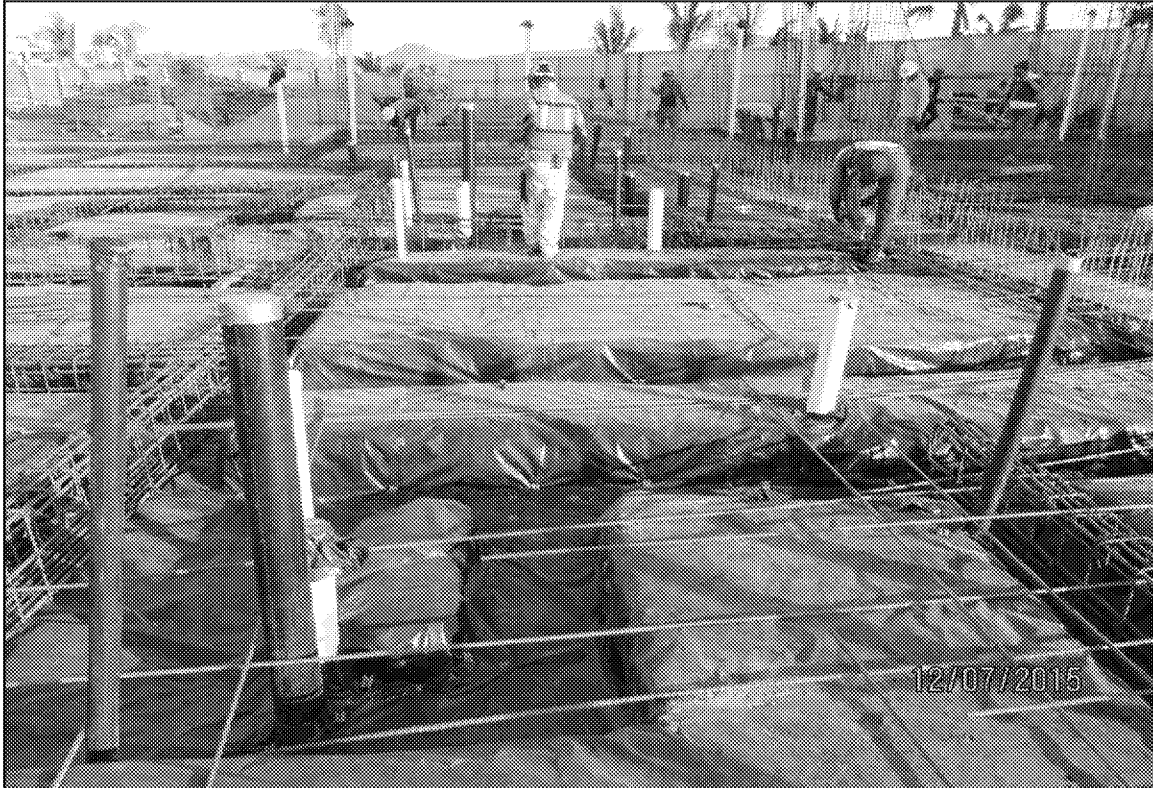
**Photograph 95:** Resort Low Rise 1B: Vapor barrier and underground utilities are in place and reinforcing steel for the foundations and slab on grade is being placed.

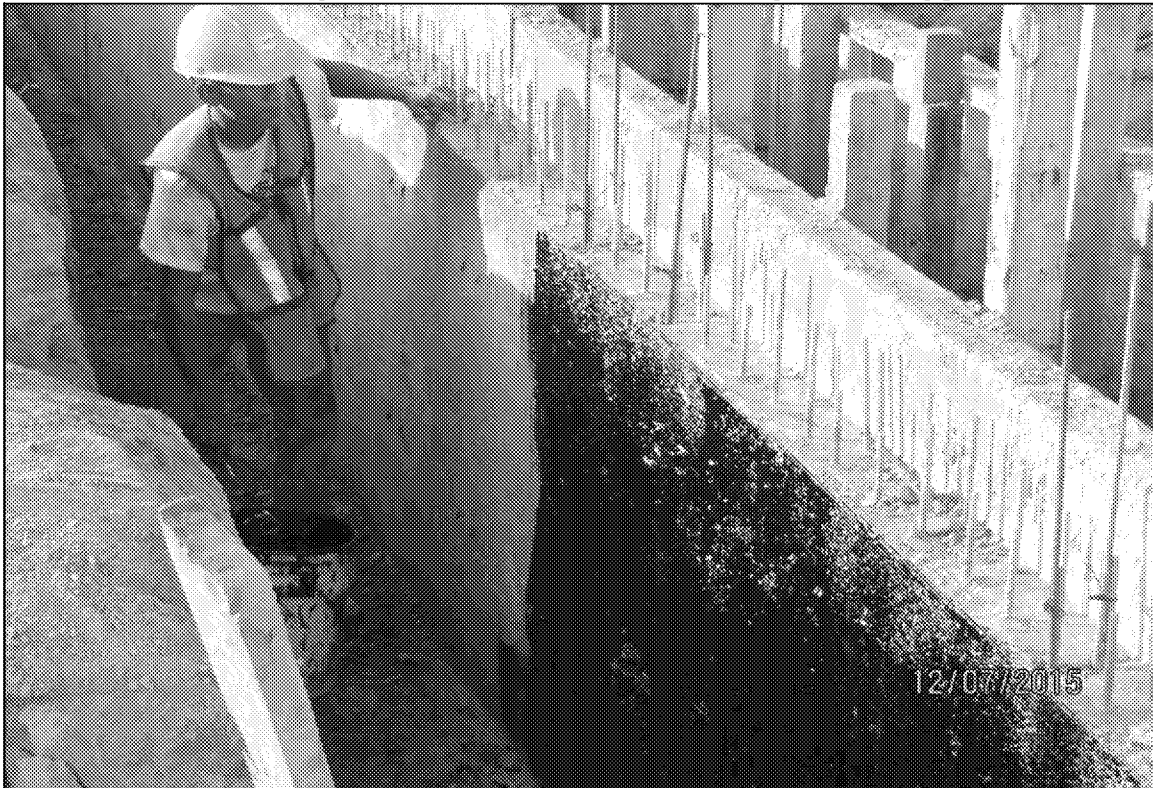
**Photograph 96:** Resort Low Rise 1B: Waterproofing is being placed on the walls of the underground utility tunnels.

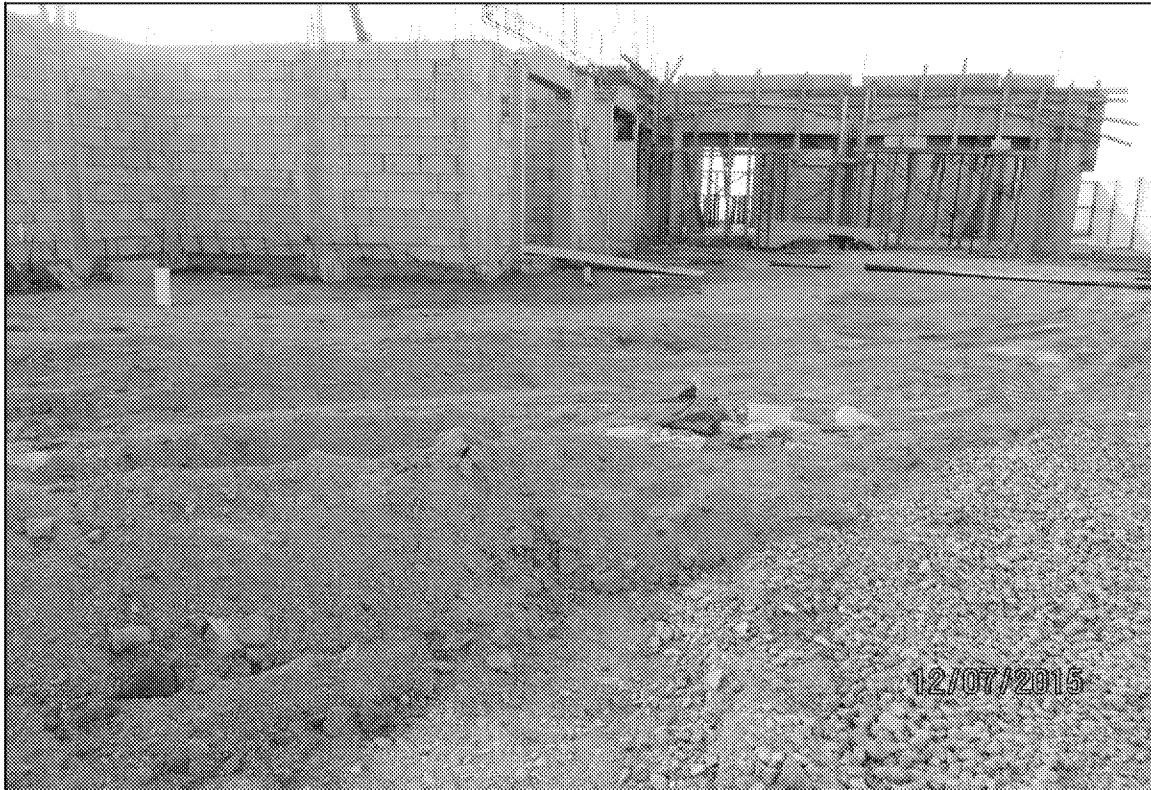
**Photograph 97:** Beach Estate 43: The ground floor CMU walls for this Residence Club Beach home are under construction.

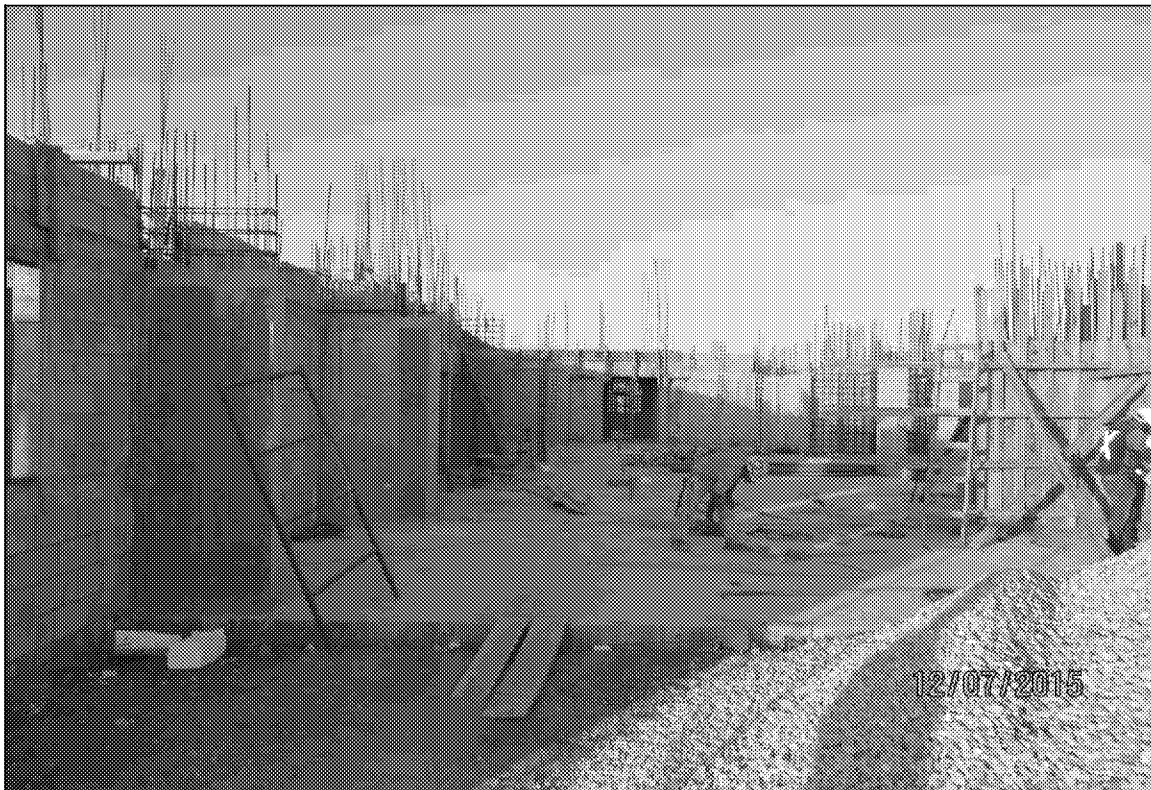
**Photograph 98:** Beach Estate 43: The slab on grade is complete and wall construction is underway. Forms are in place for the concrete wall sections.

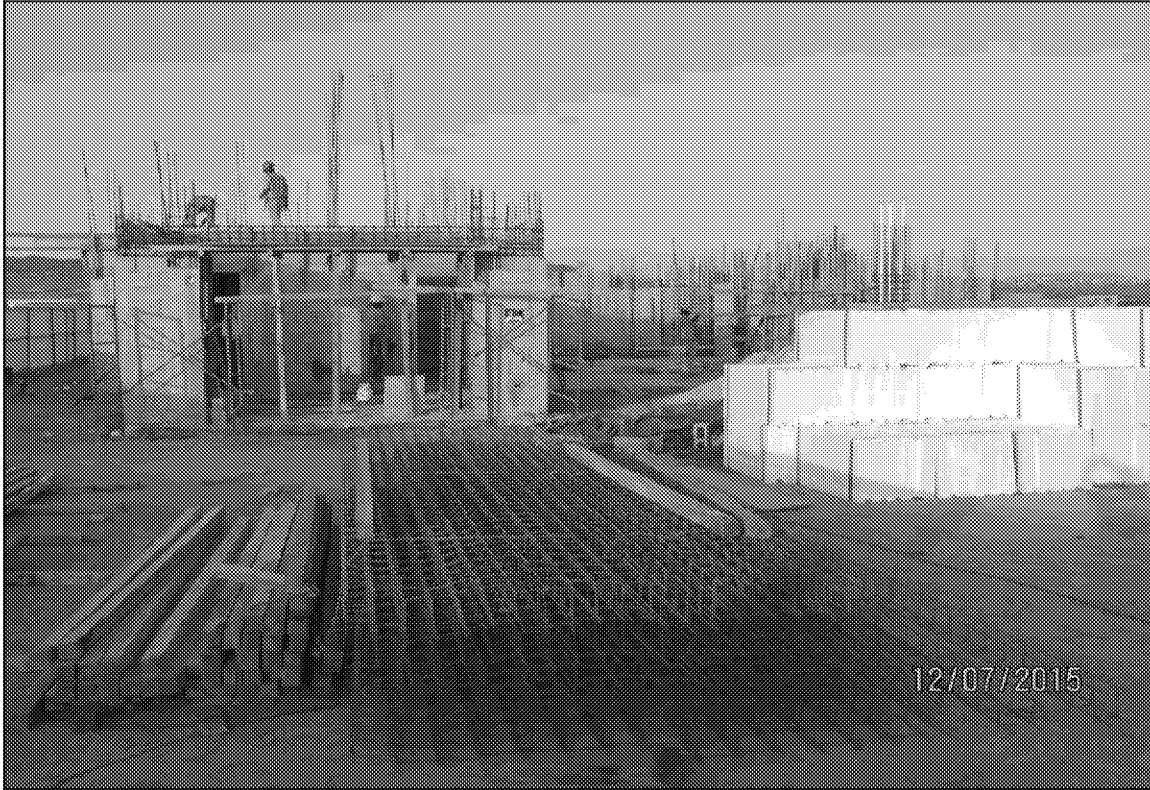
**Photograph 99:** Beach Estate 43: Building materials such as reinforcing steel and Styrofoam blocks are stored for the structure construction.

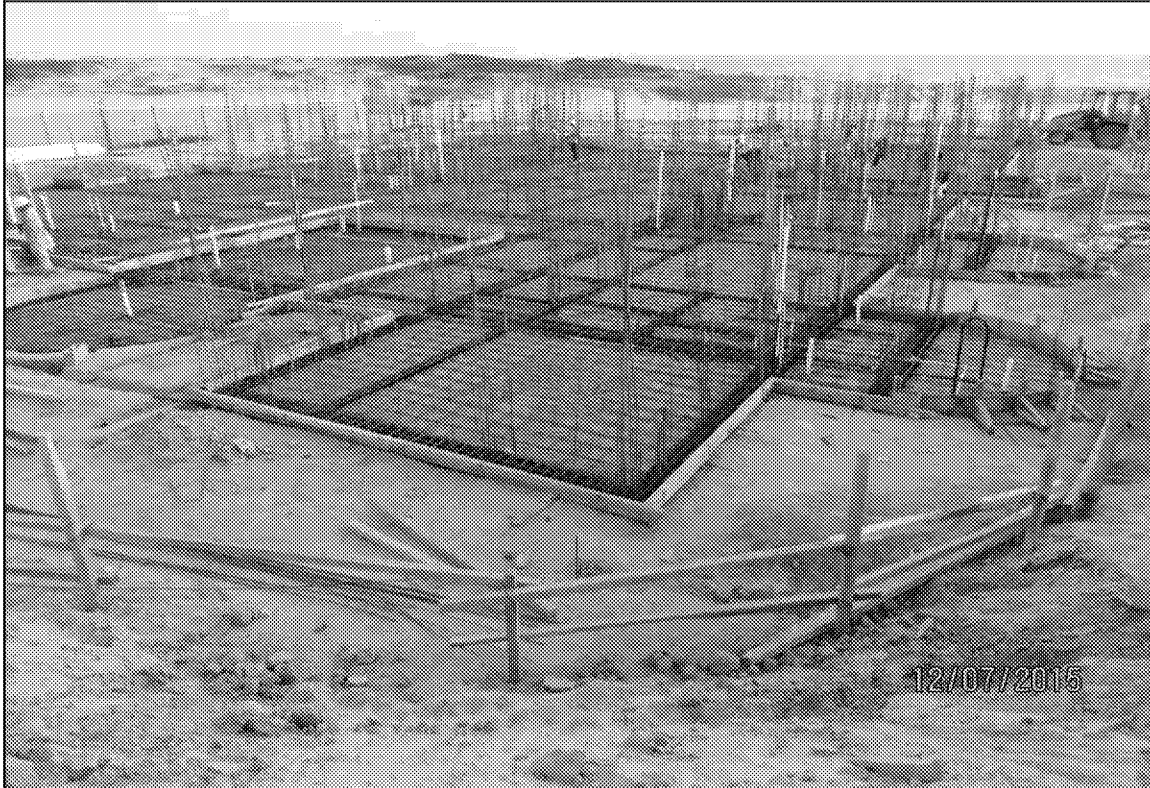
**Photograph 101:** Beach Estate 12: Foundations have been excavated and underground utilities and reinforcing steel has been placed for the foundation and slab construction of this private home by a private contractor.

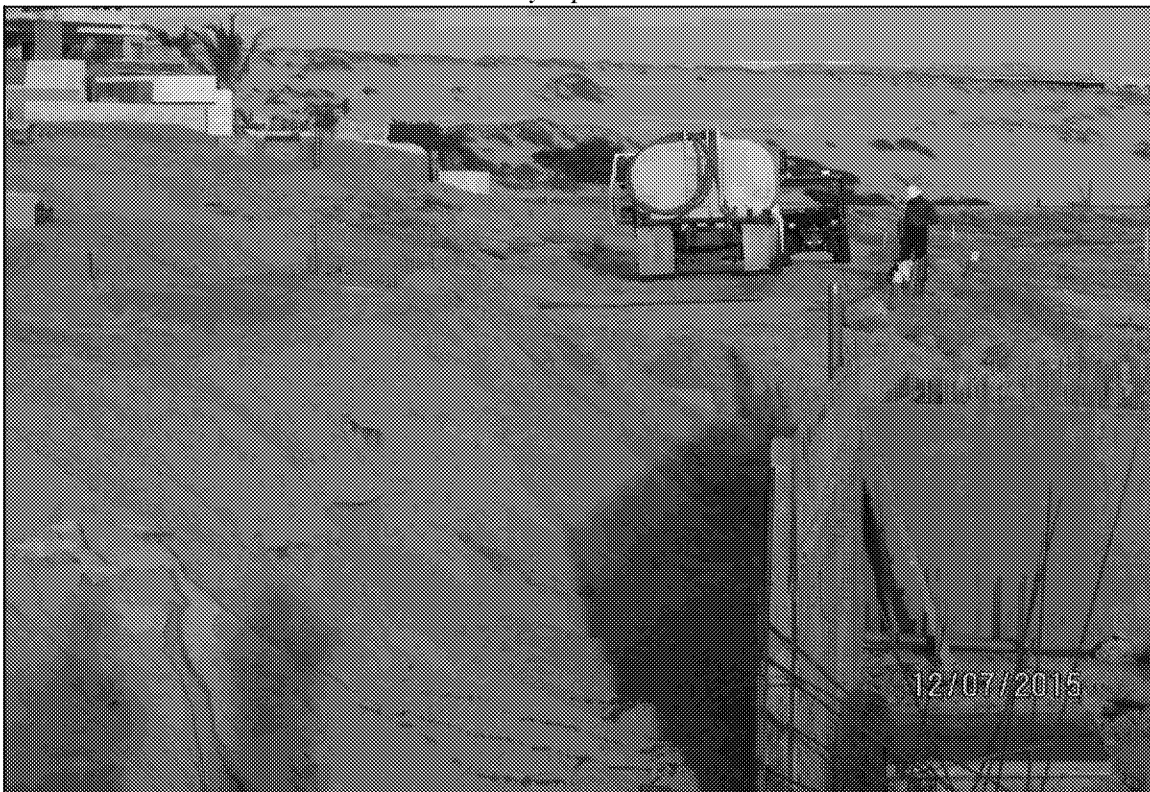
**Photograph 102:** Underground utility construction to connect services to Beach Estate 12 is underway in the road in front of this home.

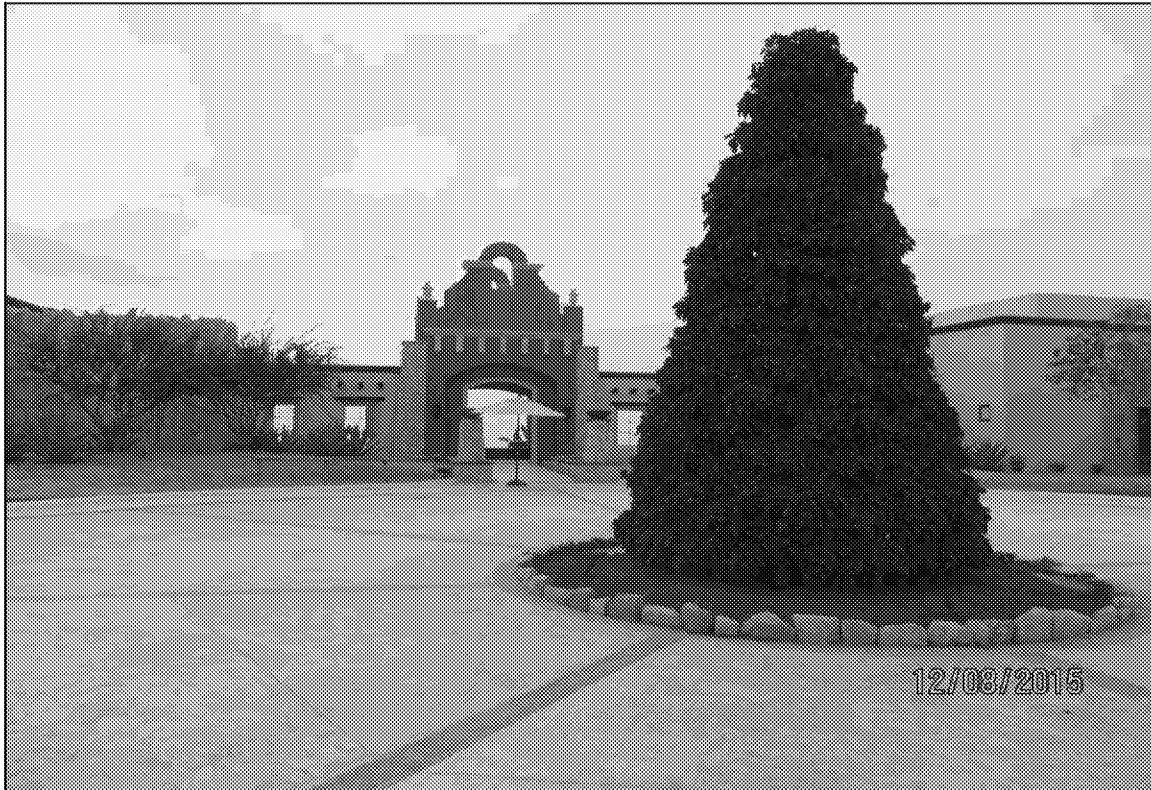
**Photograph 103:** El Cardonal Golf Course main entry: Christmas decorations have been placed in preparation for the upcoming Holiday Season.

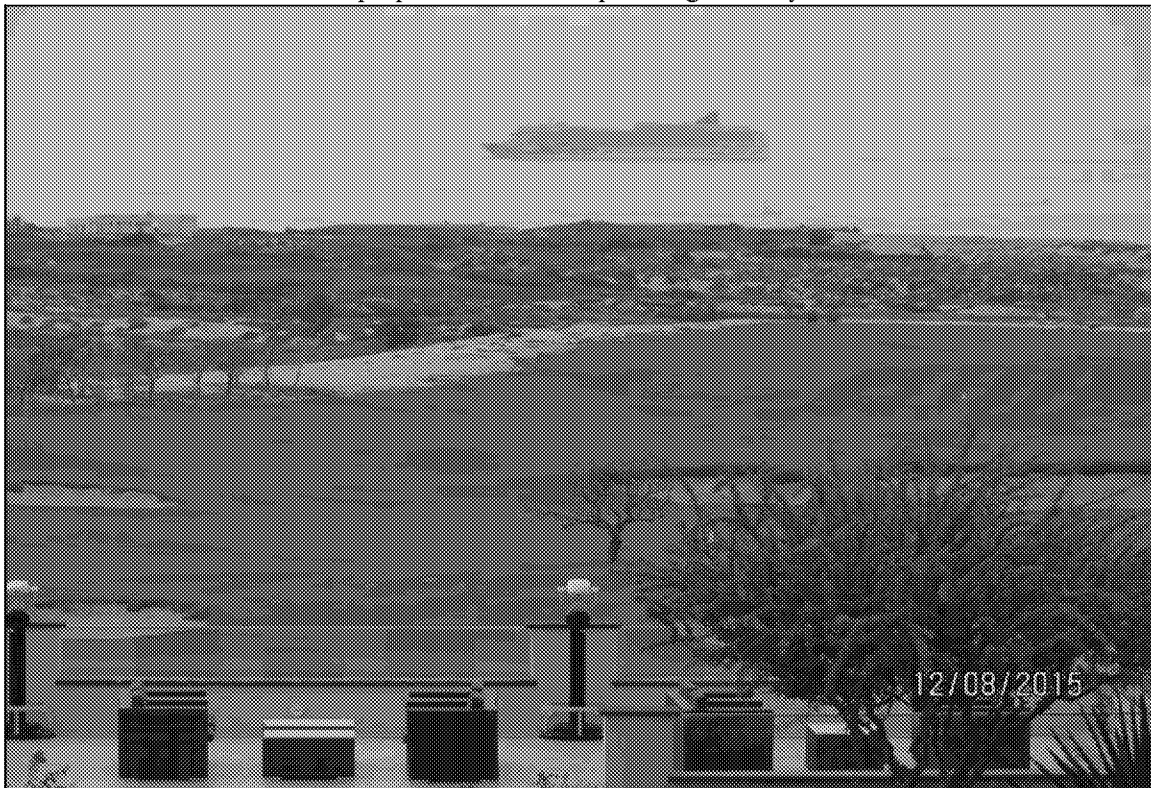
**Photograph 104:** El Cardonal Golf Course: View looking over the practice facility shows grass and other vegetation which has grown in nicely.

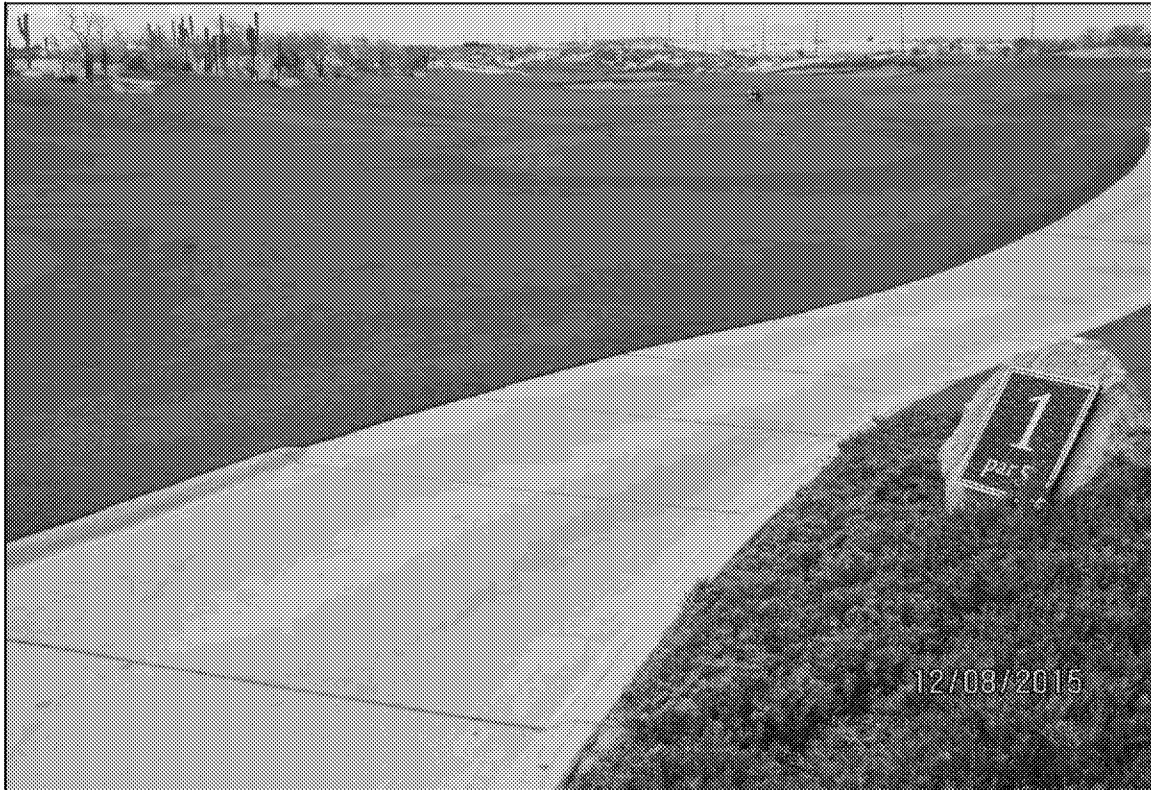
**Photograph 105:** El Cardonal Golf Course: The golf course which opened 1-year ago has grown in nicely.

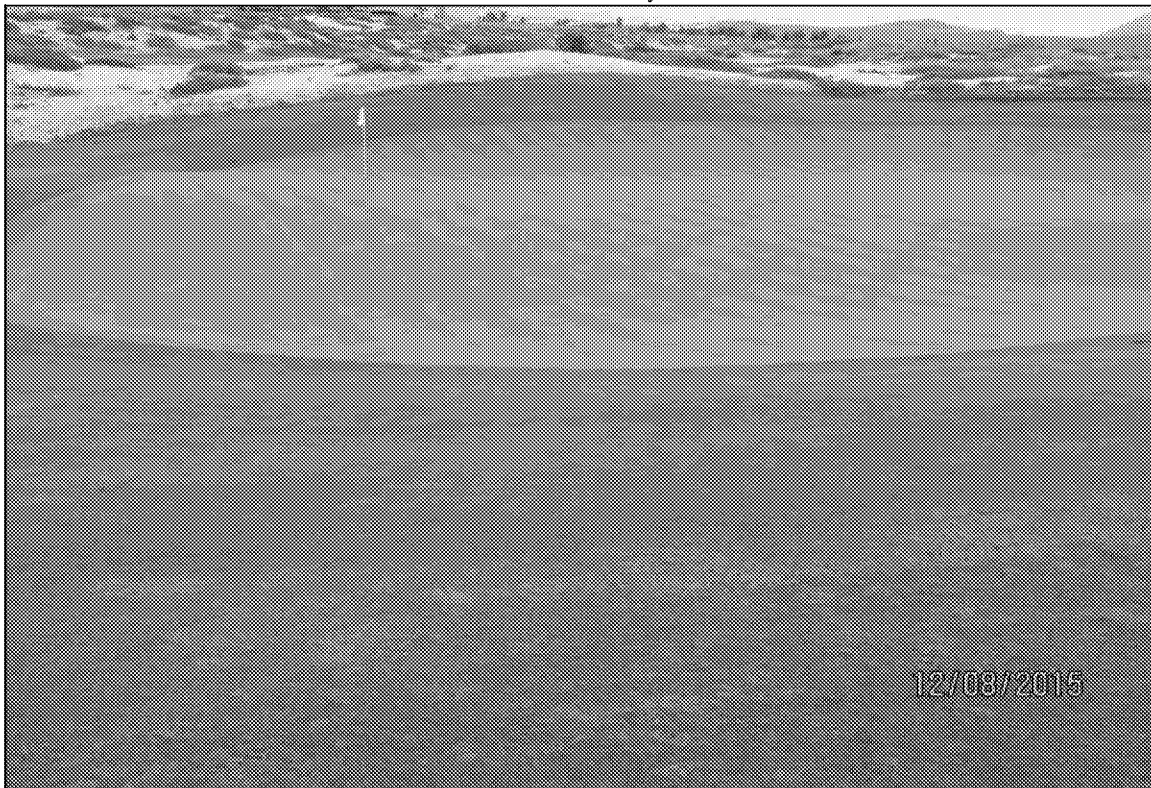
**Photograph 106:** El Cardonal Golf Course: Golf Hole No. 2 green is typical of the golf holes and is lush and in excellent playing condition.

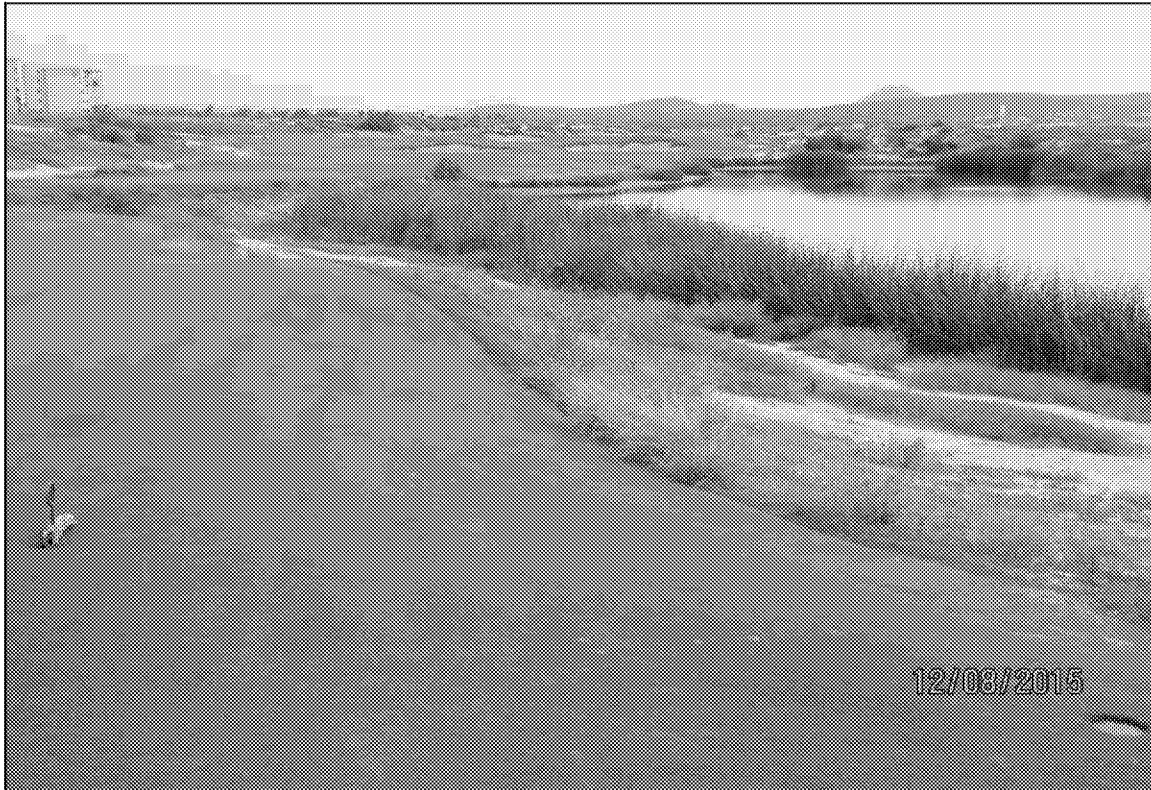
**Photograph 107:** El Cardonal Irrigation Lake, adjacent to Hole 3: Note the grass of the golf hole as well as the vegetation around the lake has grown in very well.

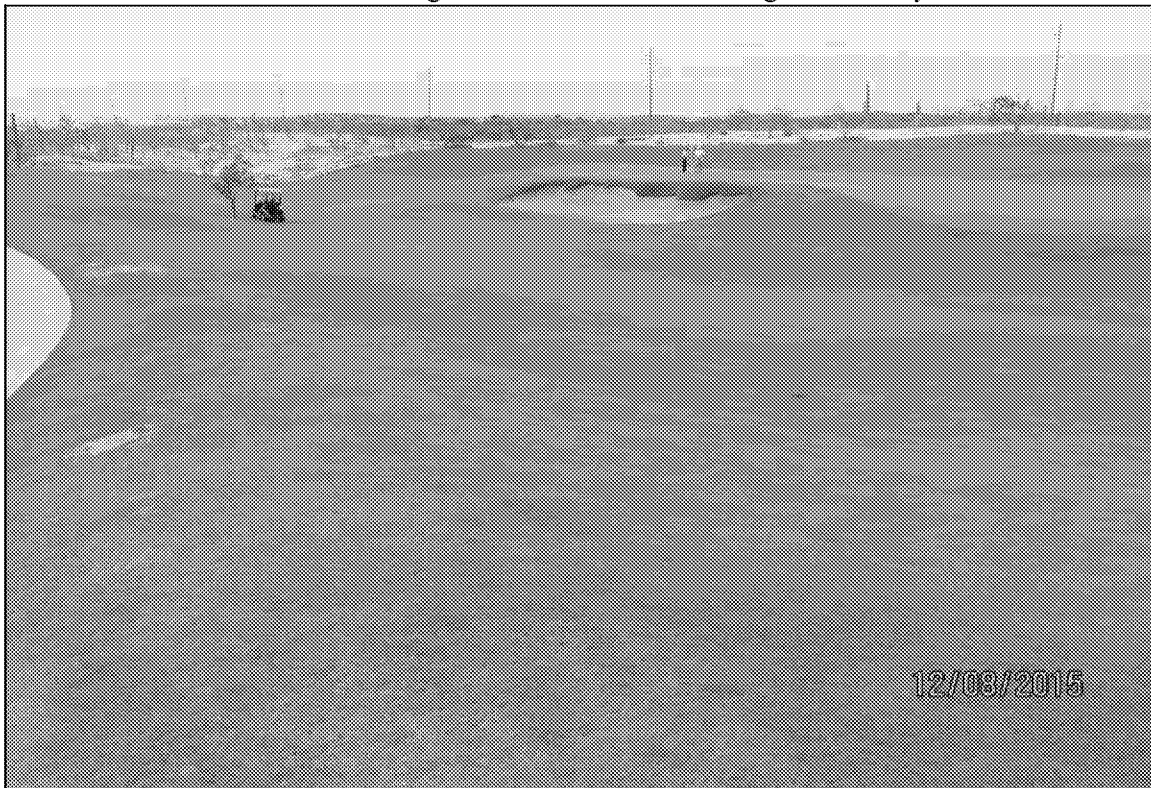
**Photograph 108:** El Cardonal Golf Hole 18: The green and surrounding slopes have grown in. This is the most heavily trafficked area of the golf course with carts passing through this area to exit the golf course, and the grass is in good condition.
